Grande Prairie

Vehicle Emissions Testing Clinic

June 5th and 6th 2012

Final Report

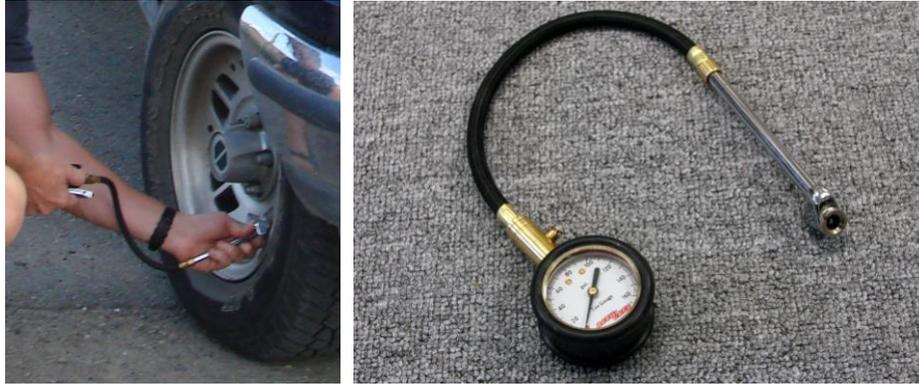
- **Tire Pressures** were checked using mechanical gauges. All four pressures were recorded; then, in consultation with the vehicle owner and after checking any information on the vehicle decals, the tires that needed it were adjusted upward or downward to the correct pressure as needed.

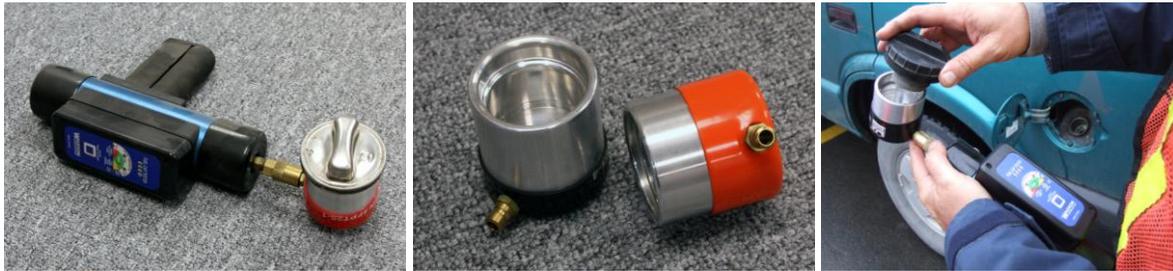
- **Gas Caps** on all 1997 and older vehicles were removed and pressure-tested using Waekon hand-held testers they were also tested on 1996 and newer vehicles if there were OBD trouble codes that indicated evaporative system leaks . Diesel caps were not tested because diesel vehicles do not have evaporative emission controls. Most gas caps from 1998 and newer vehicles were not tested, because their sealing ability is regularly checked by the vehicle's OBD system.

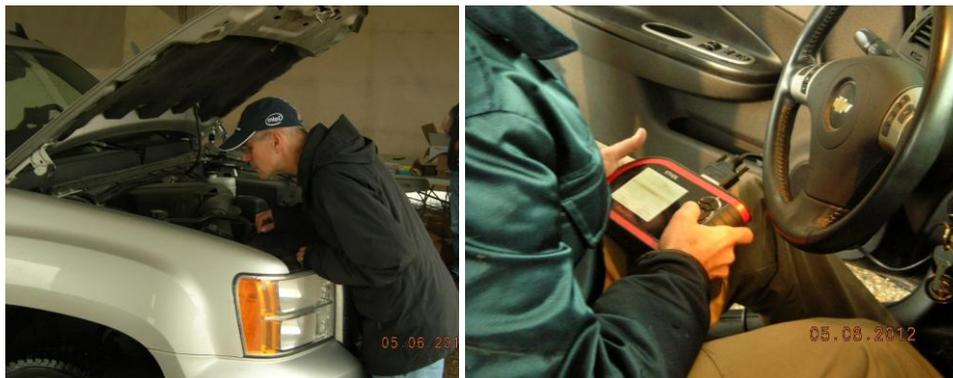
- **Emission Control System** components were checked on 1997-and-older model year vehicles for evidence of tampering or removal. In most cases, the components to be checked were as indicated on the underhood emissions decal. Typical ECS components checked were: Catalytic Converter; Positive Crankcase Ventilation (PCV) valve; Exhaust gas Recirculation (EGR) valve; Air Injection System (AIS); and Evaporative Canister.

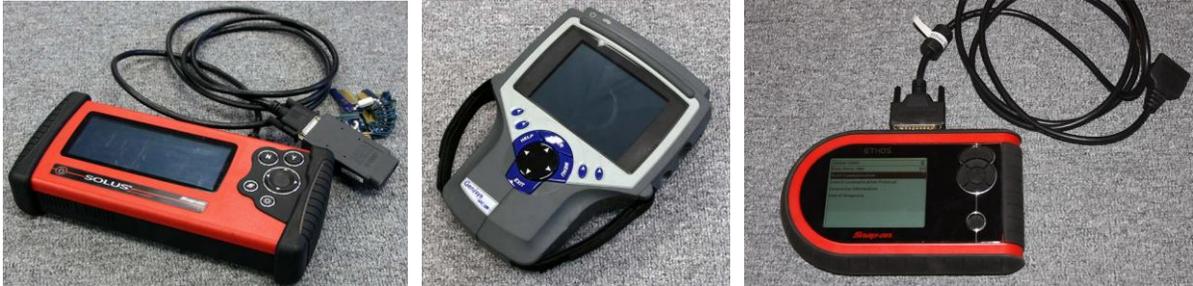
- OBD Inspection** was performed using an OTC Genisys scanner, Snap-On Solus scanner, or Snap-on Ethos scanner connected to the Diagnostic Link Connector (DLC). It also included visual Key-On Engine-Off (KOEO) and Key-On Engine-Running (KOER) Malfunction Indicator Lamp (MIL) checks. All monitors were recorded as 'ready', 'not ready', or 'not supported'. The MIL command status was checked, and any Diagnostic Trouble Codes (DTCs) were noted.

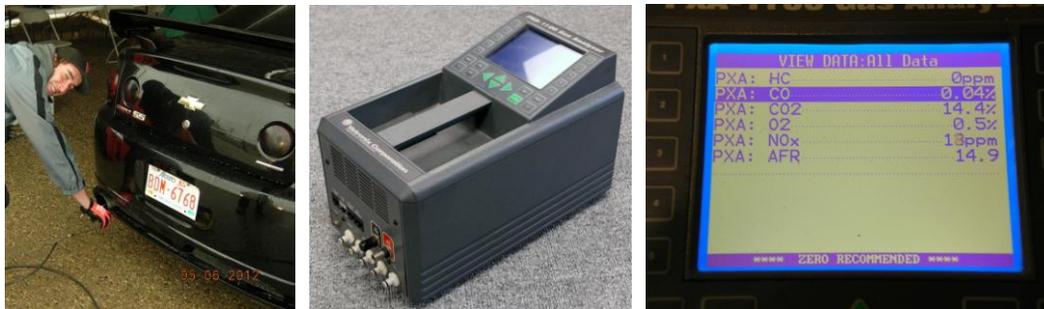
- The Tailpipe Test** for non-diesel vehicles consisted of a Two-Speed Idle test: a high-idle at 2500 rpm, followed by a curb idle (foot off the accelerator). Concentration measurements of, Hydrocarbons (HC), Carbon Monoxide (CO), Carbon Dioxide (CO₂), and Oxygen (O₂) were taken using Vetrinix portable 5-gas analysers. [The fifth gas measured is Oxides of Nitrogen (NO_x), but NO_x is only emitted in meaningful quantities when an engine is under load, so the values were not recorded.] The cutpoints used to determine PASS or FAIL for the curb idle test were the same as those used for idle tests in the AirCare program, and are functions of the vehicle type, its age, and its engine size. They range from 70 ppm to 250 ppm HC and from 0.36% to 2.50% CO. For the 2500 rpm, high-idle test, the pass/fail limits were set at 220 ppm for HC and 1.2% for CO, consistent with U.S. EPA guidelines for such a test.

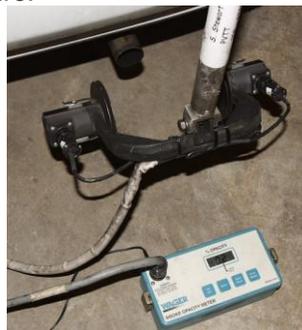
- Smoke Opacity** of diesel exhaust was measured using a Wager full-flow Opacimeter using the SAE J1667 Snap Acceleration Test procedure.

Two of the pick-ups had smoke opacity results around 30%, which is significant and objectionable, and for this age of truck is often caused by an aftermarket engine control computer or other modifications.

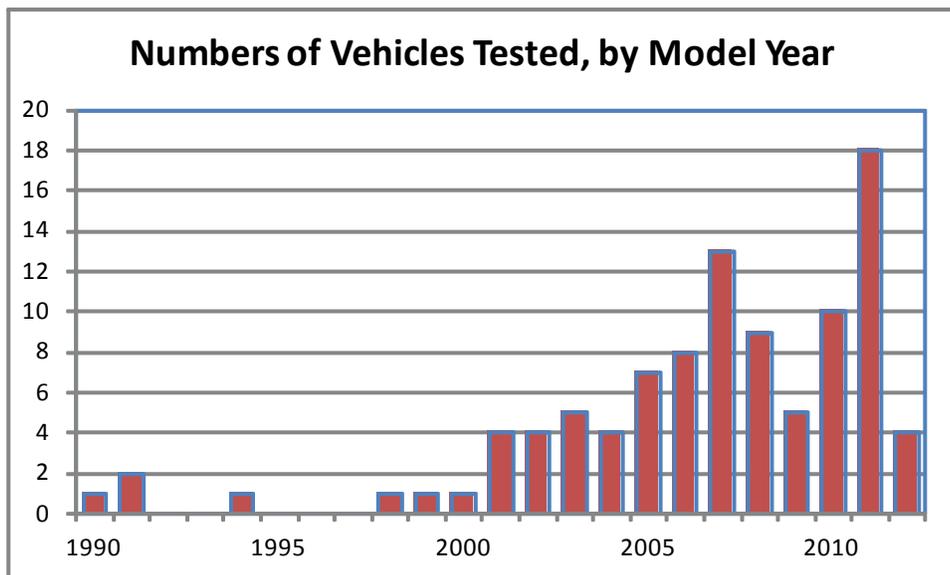
The model year distribution can be seen in the following chart. This is a very different profile to what we have seen in clinics elsewhere, and it may not be representative of the in-use fleet. Our normal expectation is for the average age of in-use vehicles to be about 8 years, and other clinics have attracted more participation from vehicles that are older than average. The vehicles tested in Grande Prairie were almost all newer than the 2000 model year. It is not impossible that this is a true reflection of the vehicles in use in the area, but the explanation may be that this age profile is simply more indicative of what work vehicles the participants were driving on the day.

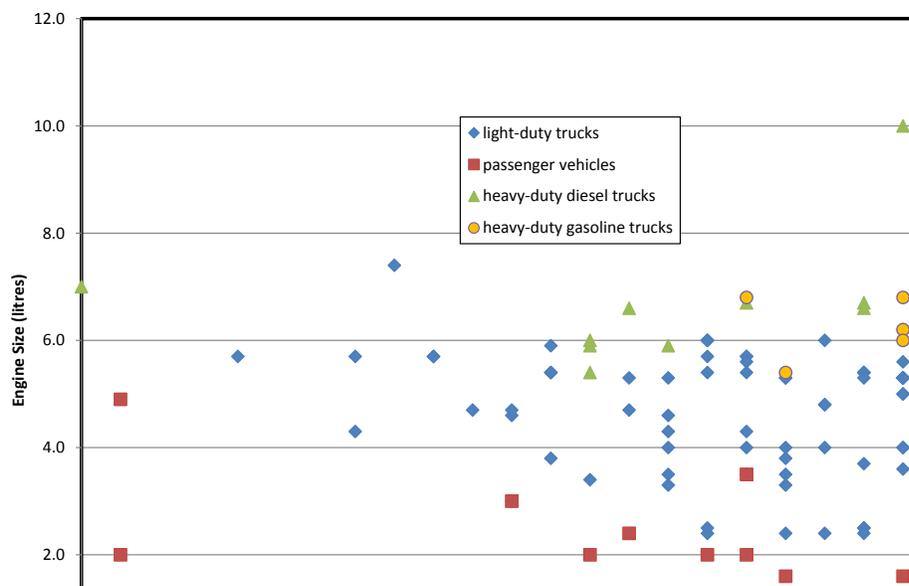
Engine Size Distribution, by Vehicle Type and Model year

There is no real relationship engine size and model year, but the data is plotted below. It simply shows that cars do tend to have smaller engines than trucks, and that the biggest engines are typically in heavy-duty diesel trucks.

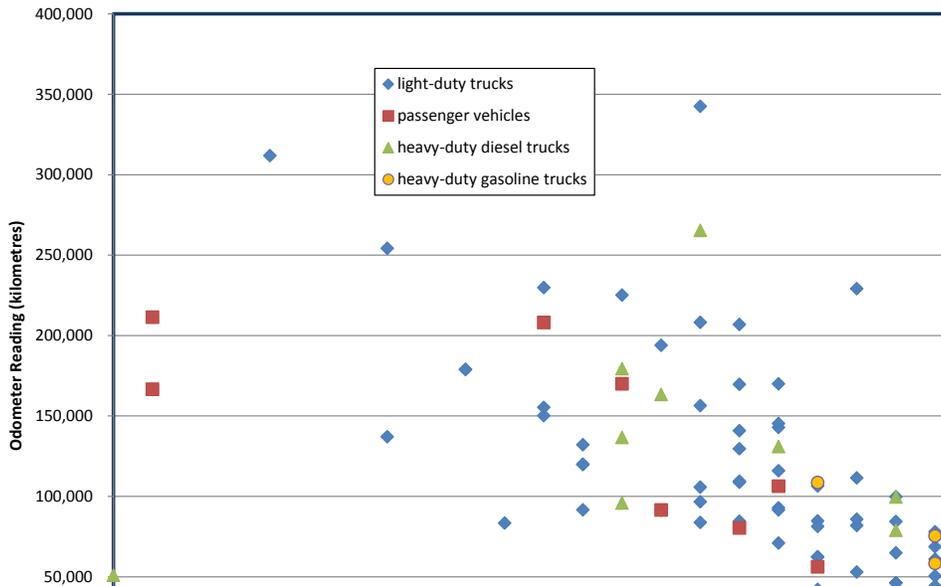
Odometer Reading Distribution, by Vehicle Type and Model

Of all the charts plotted in this report, the following shows the clearest dependency on vehicle model year. It suggests that annual mileage averages about 20,000 km/year over the first 10 years of life, with no discernable difference between trucks and cars. This is a higher annual mileage than observed in the Vancouver region.

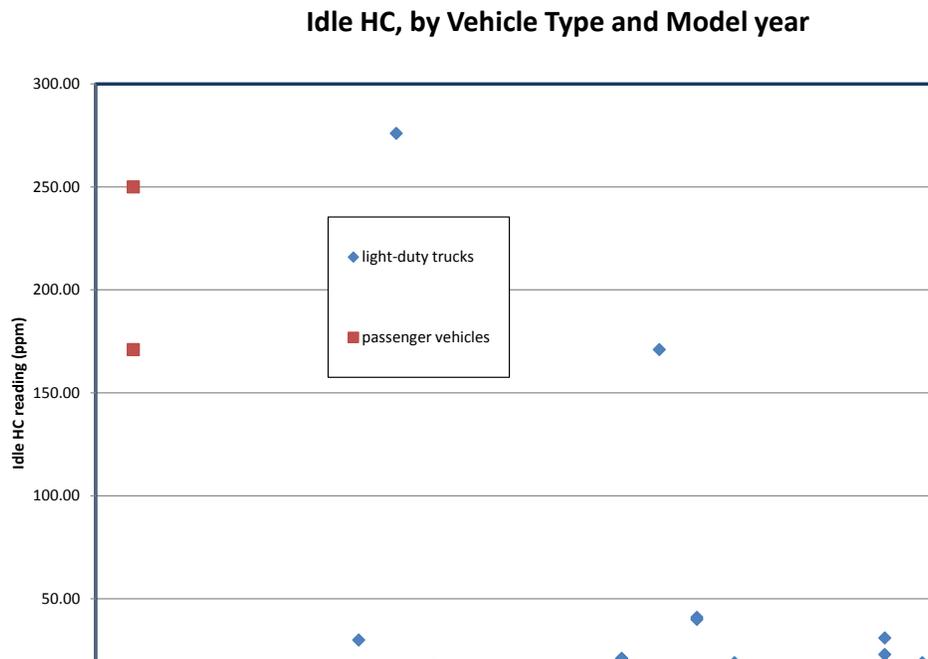
The following plots show the distributions of HC and CO readings by model year.

For most vehicles tested there appears to be no relationship between the vehicle age, or vehicle type, and its emission readings. This is what one should expect from vehicles up to about ten years old and having about the same level of emission control technology. The readings plotted basically indicate the emission levels that should come from vehicles that are running the way they were intended to run, and the variation shown is all well within natural variation for normal vehicles.

- A 1998 GMC Sierra had curb-idle HC of 276ppm, but the peak value observed was 1400ppm.
- A 1999 Chevrolet Tahoe had curb-idle CO of 2.0% which is too high to appear on the graph and is very much higher than normal. However its high-idle reading was 0.08% which does indicate good catalyst efficiency.
